TECHNICAL REPORT REMR-CO-3

**CASE HISTORIES OF CORPS BREAKWATER
AND JETTY STRUCTURES**

Report 8

LOWER MISSISSIPPI VALLEY DIVISION

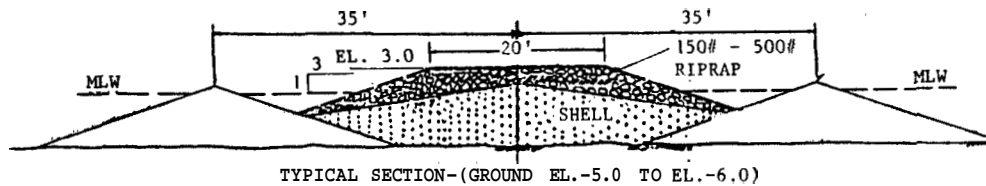
a. North jetty, 1960

1961	Capping stone was placed on the existing north jetty, and south jetty construction was completed between 2264+00 and 2420+00. On the north jetty, between 2262+50 and 2420+00, capping stone was placed to an elevation of +5 ft mlg, a crest width of 12 ft, and 1V:1.5H side slopes (Figure 4b). Stone size varied from 200 lb to 4 tons with 80 percent ranging from 2 to 4 tons. The larger pieces were placed on exposed surfaces. Existing jetty elevations, prior to capping, varied from +2 to +3 ft mlg. A total of 59,860 tons of stone was placed at a cost of \$428,700. South jetty construction was identical to 1960 Phase I construction of the north jetty. The jetties are parallel and spaced 1,400 ft apart (Figure 3). A total of 115,190 tons of riprap and 90,360 cu yd of shell was placed at a cost of \$846,300.
1962	The south jetty was capped between 2262+50 and 2420+00, with 4- to 6-ton stone. In addition, 500-lb to 2-ton stone was placed in a 2-ft-thick by 15-ft-wide layer on the channel side slope of the jetty adjacent to the capped section (Figure 4c). The cap design geometry was identical to the north jetty cap of 1961, with a +5 ft mlg crown elevation, 12-ft crown width, and 1V:1.5H side slopes. Prior to capping, typical elevations on the Jetty (February 1962 survey) were from +1.5 to +3 ft mlg. A total of 107,500 tons of stone was placed at a cost of \$717,100.

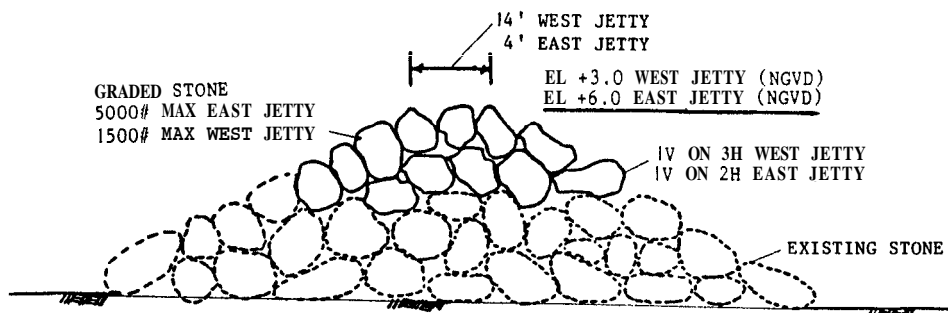
c. Jetty repair, 1984

1984	<p>Repairs were made on the seaward end of the west jetty for a distance of 4,550 ft, and the entire east jetty was repaired (Figure 6c). (These were called repairs even though the original design called for two-phase construction.) Existing (1983 survey) center-line elevations on sections to be repaired were from +1 to +3 ft National Geodetic Vertical Datum (NGVD) on the west jetty and from +2 to +5 ft NGVD on the east jetty. (NGVD datum is about 0.5 ft above mlg datum).</p>

Date(s)	Construction and Rehabilitation History
1984 (cont.)	<p>It appears that use of the plastic filter fabric in test sections to separate shelf materials has had little, if any, effect in retarding the rate of jetty settlement. The west jetty was brought up to +3 ft NGVD with a 14-ft crown width and 1V:3H side slopes. The east jetty was brought up to +6 ft NGVD with a 4-ft crown width and 1V:2H side slopes. Cost of the repairs was \$512,000 with 22,100 tons of graded stone (5,000-lb maximum) placed on the east jetty and 11,500 tons of graded stone (1,500-lb maximum) placed on the west jetty.</p>

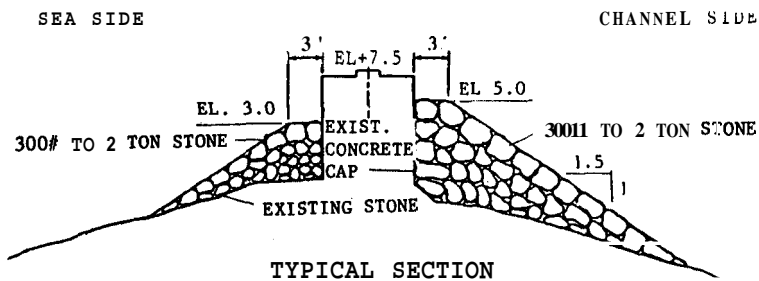
Figure 10. Stone buttressing of the concrete cap on the South Pass east jetty, 1966

1966	The east jetty concrete cap was buttressed with stone (Figure 10) along 3,800- and 6,700-ft-long sections on the sea and channel sides,

Date(s)	Construction and Rehabilitation History
1966 (cont.)	respectively, both sections terminating at the seaward end. The 300-lb to 2-ton stone was placed to +3 and +5 ft mlg on the sea and channel sides, respectively, with a berm width of 3 ft and 1V:1.5H side slopes. A total of 38,300 tons of stone was placed at a cost of \$264,000.
1970- 1971	Two sections of the east jetty were repaired and a 100-ft-long jetty tie-in constructed. A 650-ft section of the concrete cap, located about 5,400 ft from the seaward end, was buttressed with stone. The design geometry was identical to that used in 1966 repairs (Figure 10). A 300-ft section and tie-in section, located 6,900 and 8,500 ft from the outer end, respectively, were built up to +7.5 ft mlg, with a 6-ft crown width and 1V:1.5H side slopes. The repairs were made with 300-lb to 2-ton stone, and a 1-ft-thick layer of shell was placed as bedding for the jetty tie-in. A total of 16,500 tons of stone and 500 cu yd of shell was used for an approximate total cost of \$164,000.

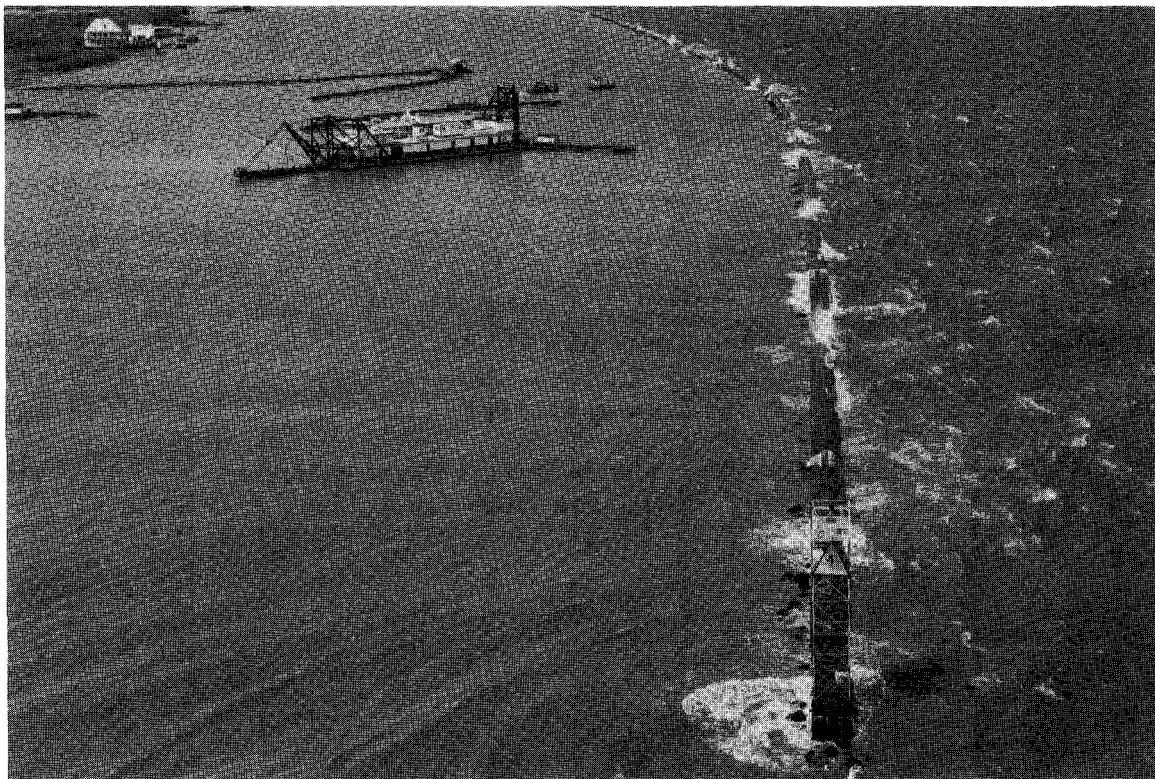
Figure 11. East jetty at South Pass, 1977

1985	No new work has been done since 1971, and the project has been essentially inactive since 1978. All deep-draft traffic now uses Southwest Pass. Figure 11 is a 1977 photograph of the east jetty.

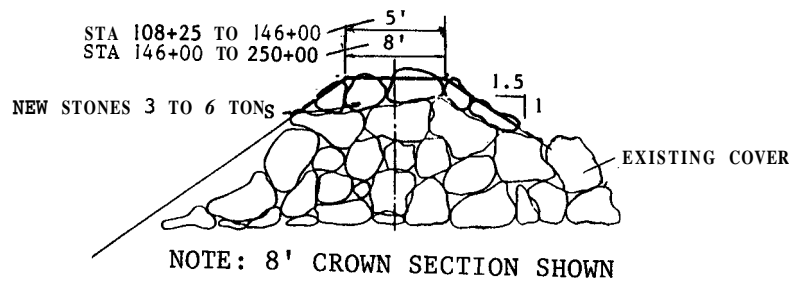
b. Typical repairs made during the 1970's

1972	The east jetty was repaired from 140+00 to 167+00 using 3- to 6-ton armor stone. The design geometry (Figure 13b) specified a +6 ft mlg crown elevation, 5- and 8-ft crown widths shoreward and seaward of 146+00, respectively, and 1V:1.5H side slopes. An April survey (before repairs) of the jetty showed an average center-line elevation of +2.5 ft mlg within the repair area, and +3 ft mlg elsewhere. Cost of the repairs was \$349,000 using 36,900 tons of stone.
1974	Two sections of the east jetty were repaired using the 1972 design geometry and stone size (Figure 13b). Crown widths were 5 ft, from 117+00 to 140+00, and 8 ft from 167+00 to 204+50. Cost of the repairs was \$1,399,000 using 64,500 tons of stone. Figure 15 is a photograph taken in February showing three dredges operating between the jetties and a grounded vessel near the seaward end.
1975	The east jetty was repaired with 3- to 6-ton stone at locations 140+00 to 158+50 and 204+50 to 249+45 (seaward end). The design geometry (Figure 13b) had an elevation of +6 ft mlg, 1V:1.5H side slopes, and an 8-ft-wide crown (except from 140+00 to 146+00 which was 5 ft wide). After repairs were completed, it was noted that additional stone between 204+50 and 249+45 would be needed to stabilize the gulf side slope because some of the new slope stones were removed during periods of heavy wave action. The total cost was \$2,306,800, and 103,660 tons of stone were required.

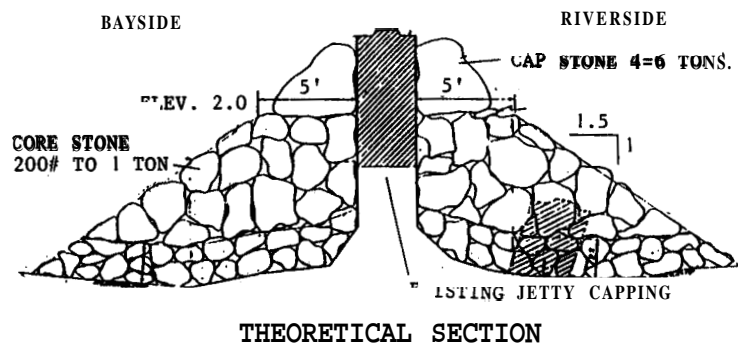
b. Buttressing of concrete cap, 1960-1961

1960	Repairs were made to the 3-ft-wide concrete cap section of the west jetty by resetting the blocks that had been dislodged during storm waves of 18 November 1957 and 16 February 1959. About 1,315 lin ft of cap was reset and buttressed with additional stone at sections 48+40 to 50+50 and 131+50 to 143+00. The design cross section (Figure 14b) used to supplement the concrete blocks consisted of a 2-ft-thick bedding layer of 25- to 200-lb stone, followed by 200- to 2,000-lb stone placed to +2 ft mlg (1V:1.5H side slopes and a 5-ft width on either side of the cap), and 4- to 6-ton stone was placed on either side of the cap. The principal purpose of buttressing was to provide a more stable cross section for the concrete blocks. The cap sections were buttressed with 16,400 tons of stone at a cost of \$173,600.

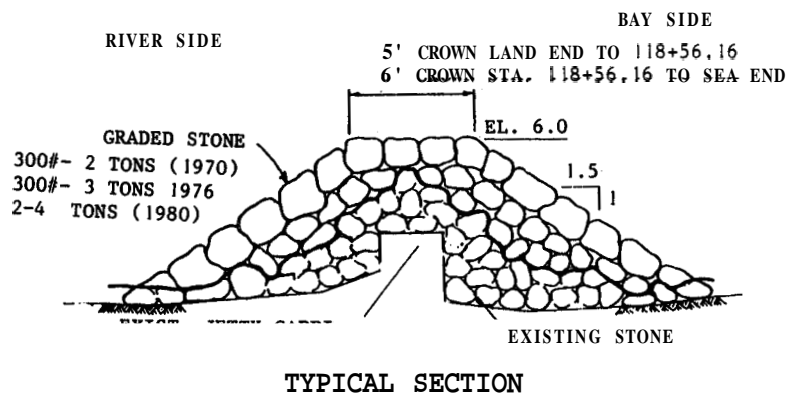
c. Typical repairs made during 1970-1980

1980	Two sections of the west jetty were repaired (Figure 14c) with armor stone (possibly 2- to 4-ton size). The crown elevation was +6 ft mlg , and the side slopes were 1V:1.5H . The landward section, from 20+00 to 63+00 , had a 5-ft crown width; and the seaward section, from 123+00 to 142+40 , had a 6-ft crown width. Prior to repairs, an April 1979 survey showed center-line elevations averaging +4 ft mlg within the repair areas and from +4 to +7 ft mlg over the remainder of the jetty. Total cost of the repair work was \$1,104,300 using approximately 43,000 tons of stone.
1981- 1982	The landward and seaward ends of the east jetty were repaired (Figure 13b) with armor stone (possibly 2 to 4 ton size) at the following locations: 108+25 (landward end) to 150+30 , 155+70 to 165+40 , and 217+55 to 250+00 (seaward end). The design geometry had a +6 ft mlg crown elevation, 1V:1.5H slide slopes, and crown widths of 5 ft (landward of 146+00) and 8 ft (seaward of 146+00). Prior to repairs, center-line elevations (September 1980 survey) varied from +4 to +6 ft mlg along the landward sections, from -2 to +6 ft mlg on the seaward section, and from +5 to +7.5 ft mlg elsewhere. Total cost of the repairs was \$820,000 using 37,500 tons of stone.

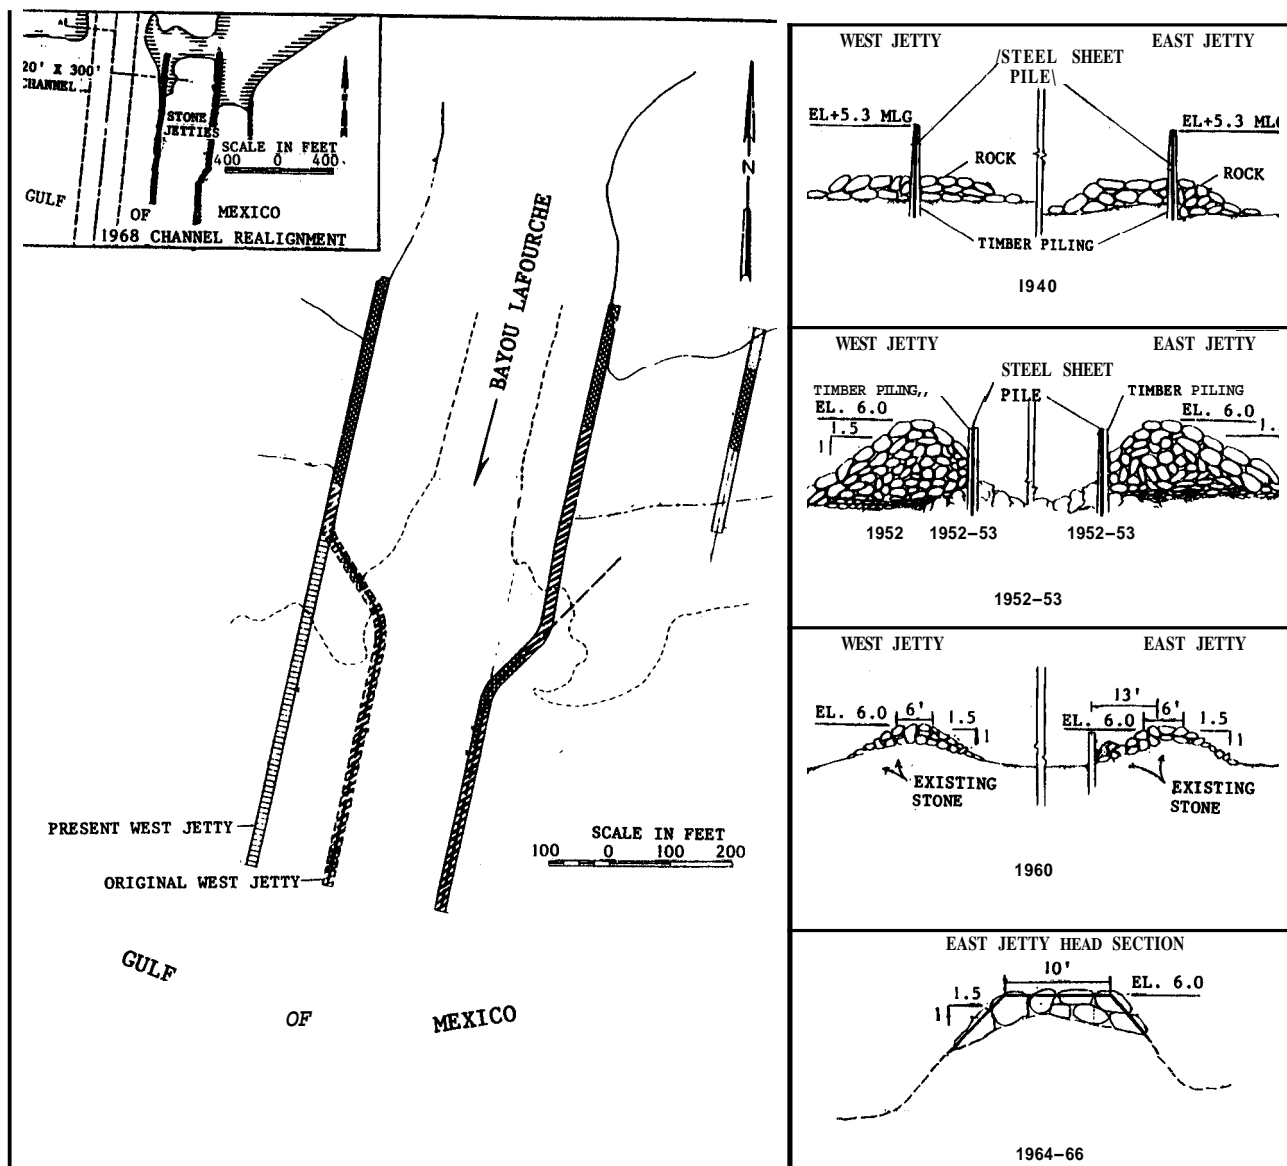
Figure 19. Plan views of Bayou Lafourche jetties and typical cross sections

1948- 1954	During this period additional stone was placed on the jetties, landward extensions were made, and a rubble-mound groin was constructed about 250 ft east of the east jetty (Figure 19). The jetties were flanked during a 1947 hurricane, necessitating repairs and landward extensions in 1948. A rubble-mound section was placed along portions of the sheet-pile jetty. In 1952 further maintenance work was done on the rubble-mound sections which were brought up to grade. Additional work was done in 1953, including landward extension of the jetties (making the total length of each about 1,000 ft) and construction of a 120-ft-long east groin. In 1954 the groin was extended seaward 120 ft, and additional work was done to bring the remainder of the jetties up to grade. By this time, stone placed on the seaward sides of the jetties had been brought up to +6 ft mlg with a 1V:1.5H side slope (same elevation and side slopes used on landward extensions). The landward jetty extensions and groin were required due to the continued recession of the shoreline, averaging about 15 ft/yr. The steel sheetpiling was still in place but was no longer considered effective. Cover stone sizes ranged up to a maximum of 6 tons.

Date(s)	Construction and Rehabilitation History
1960 (cont.)	the east jetty, and from 0- to +5 ft mlg on the groin. Soil subsidence was considered to be the major cause of jetty deterioration. Seaward sections of the east and west jetties, 700 and 800 ft long, respectively, were brought up to +6 ft mlg with a 6-ft top width and 1V:1.5H side slopes. The 345-ft-long groin was repaired to an elevation of +5 ft mlg, a 5-ft top width, and 1V:1.5H side slopes. Stone size was determined from Hudson's formula for a 9-ft depth-limited wave height. (The design called for the larger stones to be placed on the outermost surface.) The \$56,000 cost of repairs included sweeping (removing exposed rock, piles, etc.) a 150-ft-wide section along the channel side of the west jetty and placing about 4,000 tons of stone.
1964	Repairs were made to the groin and sections of the east jetty. The landward ends were extended, making the east jetty and groin 1,250 and 630 ft long, respectively. These extensions were needed due to continued recession of the shoreline, which resulted in flanking of both structures. The groin was brought up to +5 ft mlg with a 6-ft top width and 1V:1.5H side slopes, using 1- to 6-ton stone on the seaward section and 200- to 2,000-lb stone on the 250-ft landward extension. (A 1-ft-thick bedding layer was placed also.) The east jetty sections were brought up to +6 ft with 1V:1.5H side slopes using 1- to 6-ton stone. The top widths were 6 ft on the 275-ft landward (including extension) and 125-ft middle sections, and 10 ft on the 200-ft seaward end section. Prior to repairs, the center-line elevations (September 1963 survey) were from -2 to +3.5 ft mlg on the groin, from +3 to +7 ft mlg on the east jetty, and from +5 to +9 ft on the west jetty. The total cost of placing 8,240 tons of stone and 600 lin ft of sand fence was \$48,900.
